THE SERVICE STATION WAS ORIGINALLY INTENDED AS A PROTOTYPE FOR TEXACO. IT IS LOCATED APPROXIMATELY TWO KILOMETRES SOUTH OF BELLEVUE ON THE "AUTOSTRADA" FOLLOWING THE COAST BETWEEN BELLEVUE AND COPENHAGEN.

SERVICE STATION

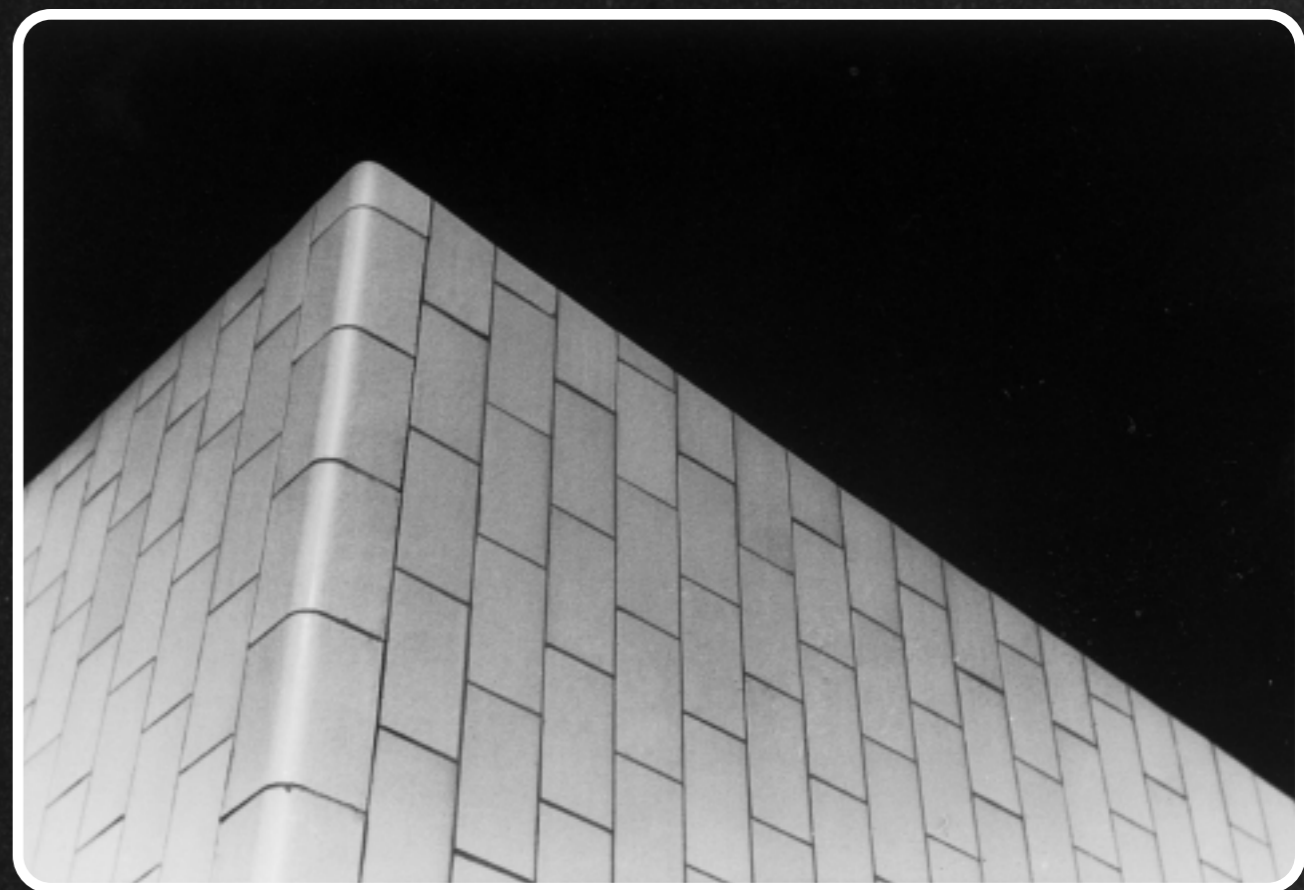
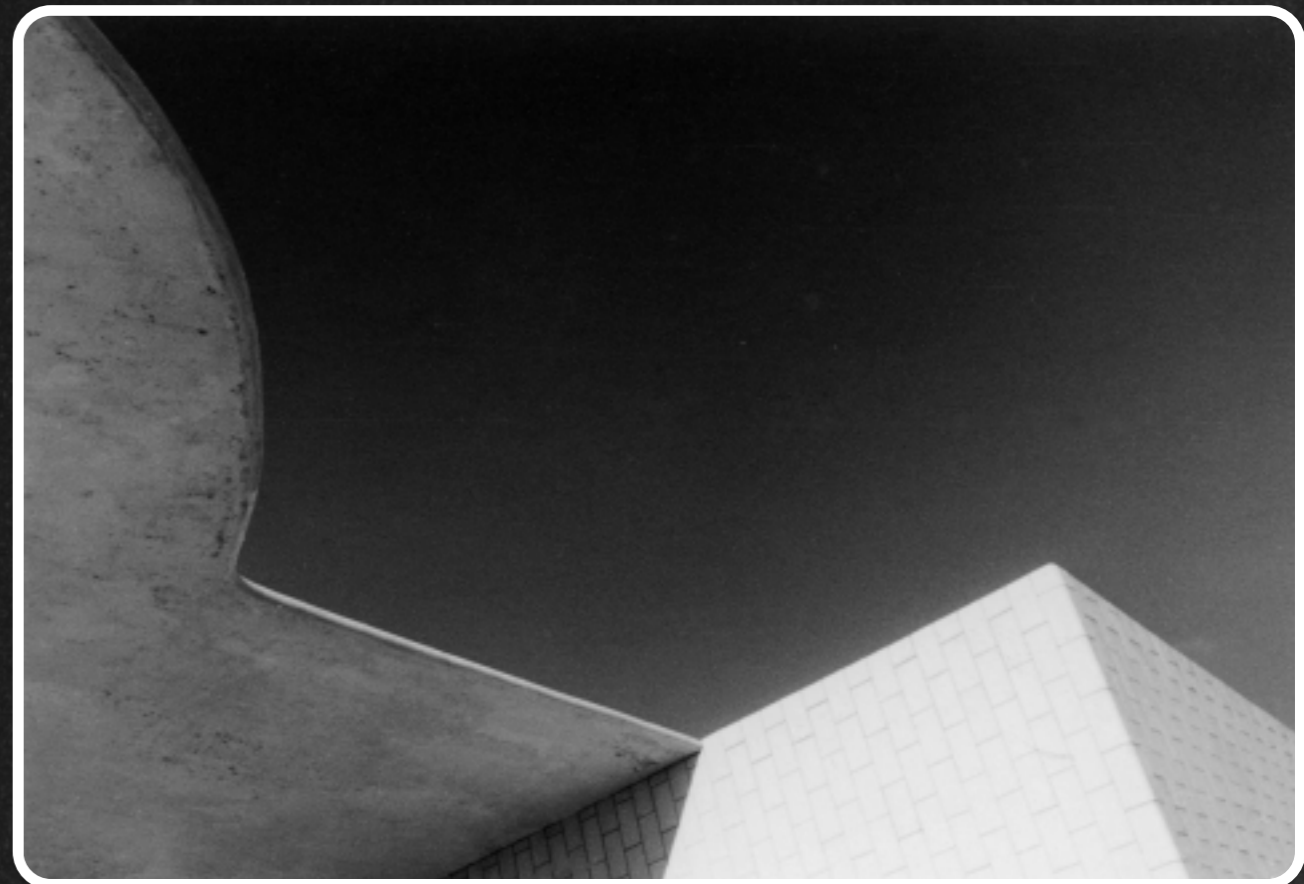
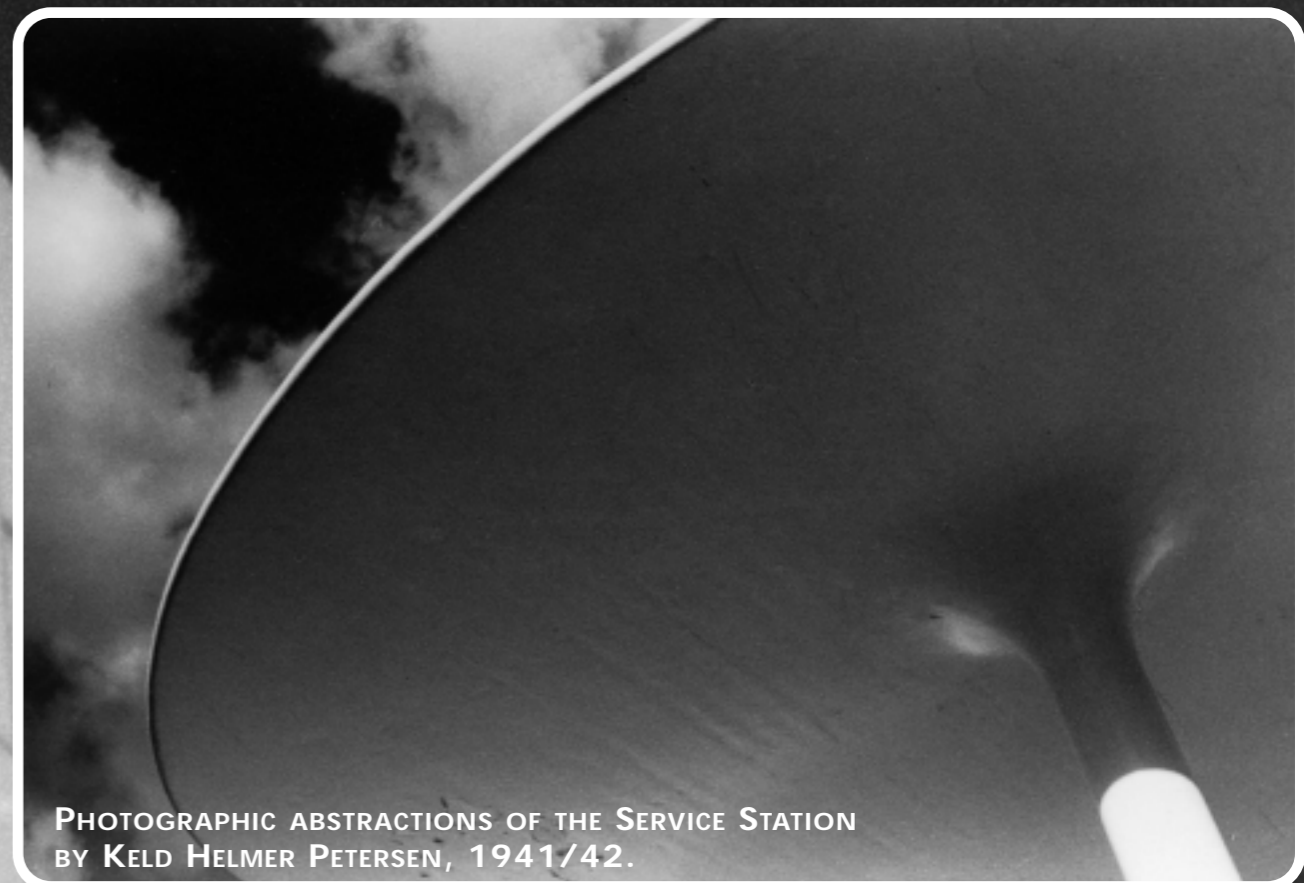
THE SERVICE STATION IS A CONCRETE STRUCTURE CLAD WITH CERAMIC TILES. THE SERVICE AREA IS COVERED BY A SINGLE BOLD AND ELEGANT OVAL CONCRETE SHELL SUPPORTED BY A SINGLE COLUMN.

PHOTOGRAPHIC ABSTRACTIONS OF THE SERVICE STATION
BY KELD HELMER PETERSEN, 1941/42.

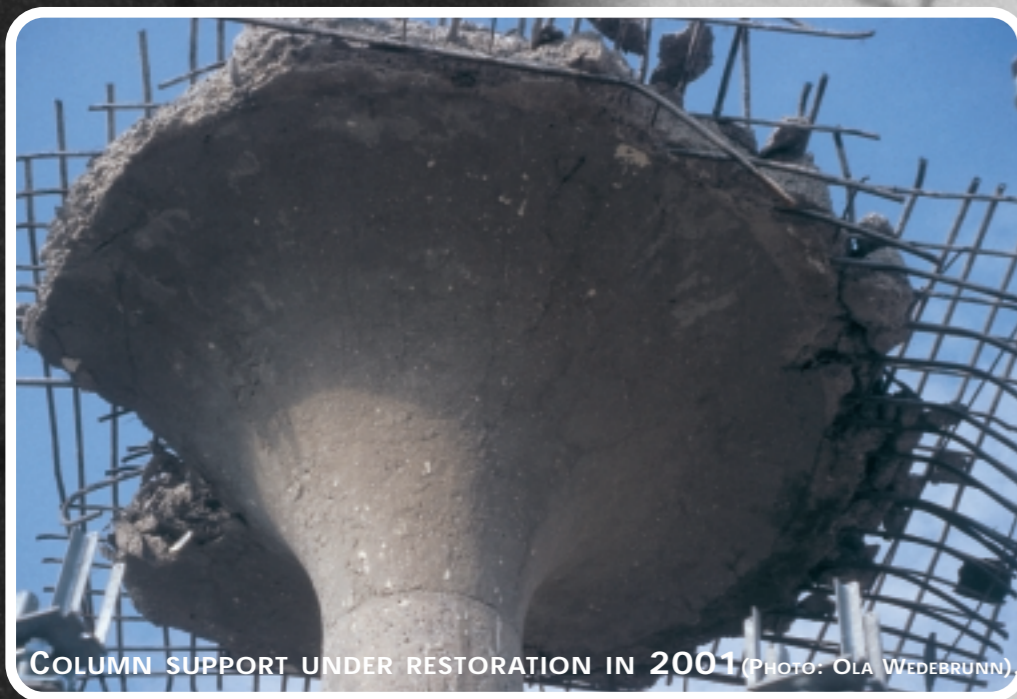
COLUMN SUPPORT UNDER RESTORATION IN 2001 (PHOTO: OLA WEDEBRUNN)

IN RECENT YEARS THE SERVICE STATION HAS BEEN SUBJECT TO EXTENSIVE RESTORATION, BY GENTOFTE MUNICIPALITY AND DISSING + WEITLING ARCHITECTS, TO SAVE IT FROM GREAT DETERIORATION AND DISREPAIR. THE ORIGINAL MEISSEN CERAMICS, HAVE BEEN REPLACED BY NEW TILES, THAT HAVE BEEN DEVELOPED THROUGH A METICULOUS COOPERATION BETWEEN THE HERITAGE AND MUNICIPAL AUTHORITIES AND THE TILE MANUFACTURER. THE ORIGINAL CONCRETE CANOPY HAS ALSO BEEN REPLACED, A DECISION MADE AFTER EXTENSIVE RESEARCH INTO VARIOUS TECHNICAL SOLUTIONS. THE CHALLENGES MET, IN TERMS OF AESTHETICS, STATICS AND MATERIALS, DURING THE RESTORATION OF THIS BUILDING HAVE BROUGHT NEW INSIGHTS AND EXPERIENCE TO THE CONSERVATION AND RESTORATION OF MODERN MOVEMENT ARCHITECTURE. WITH LAMPS BRANCHING FROM THE STALK AND THE CANOPY ABOVE AS A REFLECTOR, THE MUSHROOM CONSTRUCTION NOT SERVES AS A SHELTER BUT ALSO AS A LIGHT INSTALLATION OVER THE SERVICE AREA.
